FIELD FLOOR IMPACT INSULATION TEST REPORT

U1509, 12 CUNNINGHAM STREET, NEWSTEAD

Project number: 5835 **Version:** V.0

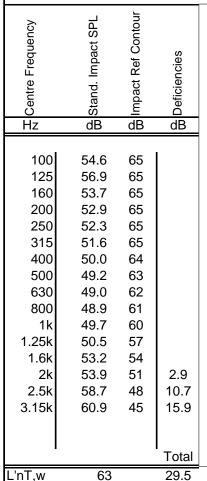
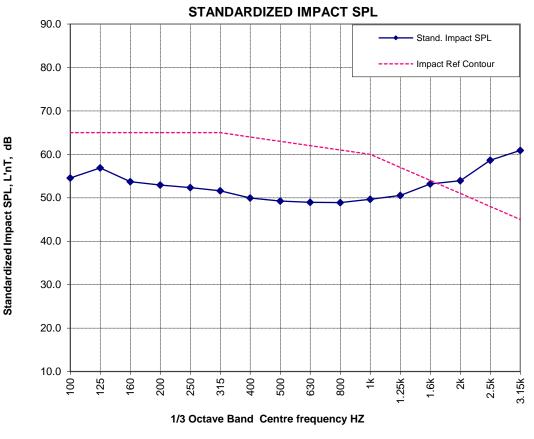
Test 1 of 3

Bare Slab

Weighted Standardized Impact SPL

Results standardized to a RT of 0.5 seconds

63

Test System	L'nT,w
1.	Bare slab – U1509 Living Area to U1409 Living Area	63
2.	Paramount Wood 5mm loose laid – U1509 Living Area to U1409 Living Area	53
3.	Paramount Wood 5mm + Regupol Sonus Multi 3mm – U1509 Living Area to	46
	U1409 Living Area	40

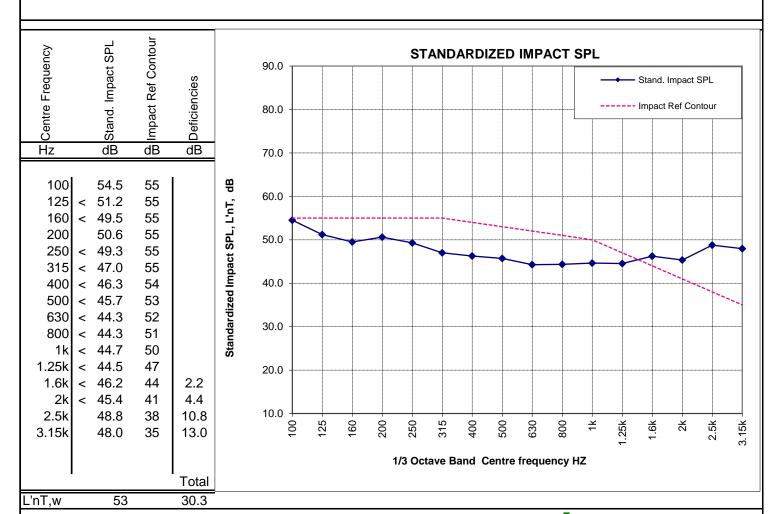
Test 2 of 3

Paramount Wood 5mm loose laid

Weighted Standardized Impact SPL

Results standardized to a RT of 0.5 seconds

53

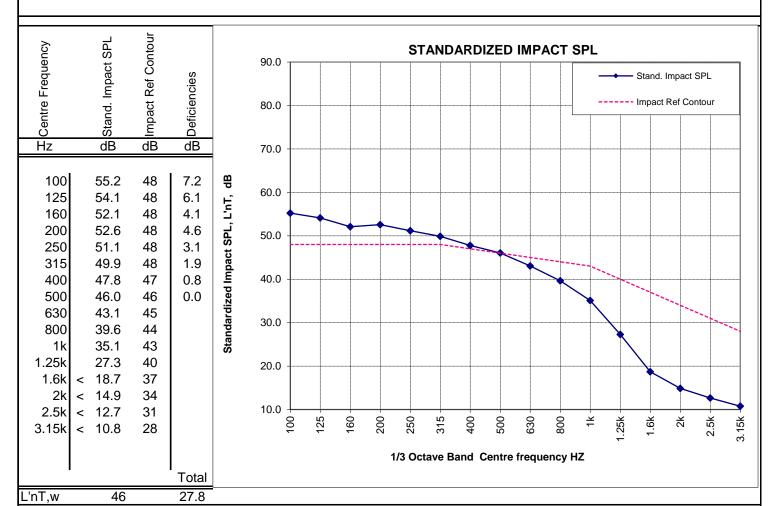
Test 3 of 3

Paramount Wood 5mm

Regupol Souns Multi 3mm

Weighted Standardized Impact SPL

Results standardized to a RT of 0.5 seconds

46
